**MILESTONE INSPECTION –  
PHASE I REPORT**

Montego Condominium  
445 Cove Tower Drive  
Naples, Florida 34110

SOCOTEC Project Number VS233602

December 2023

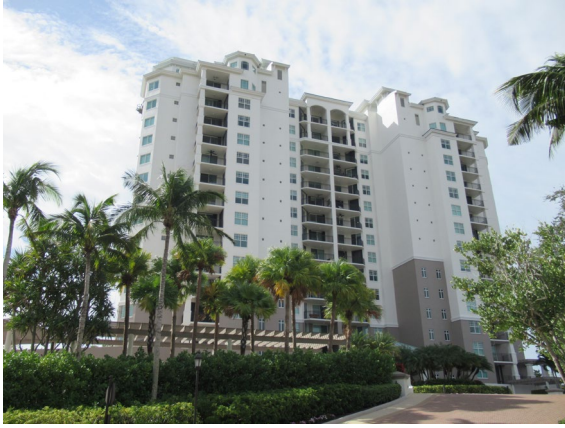
View of northern facade.

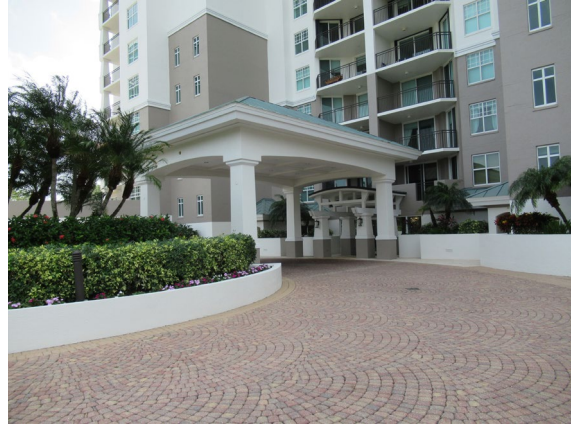
View of main entrance.

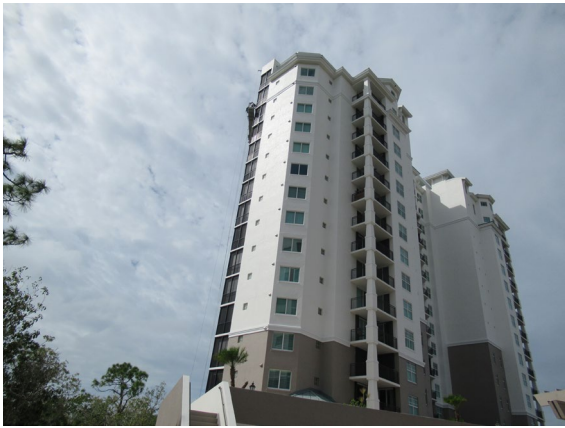
View of eastern facade.

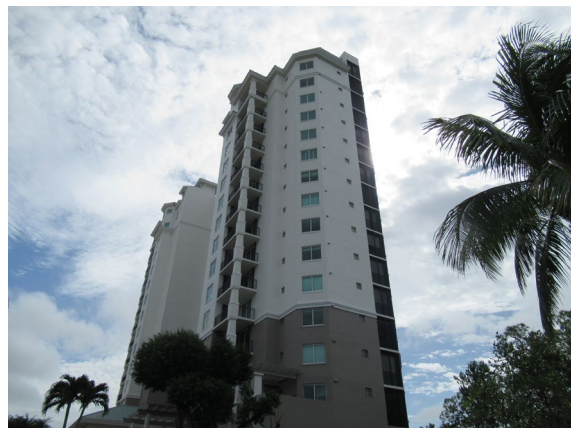
View of western facade.

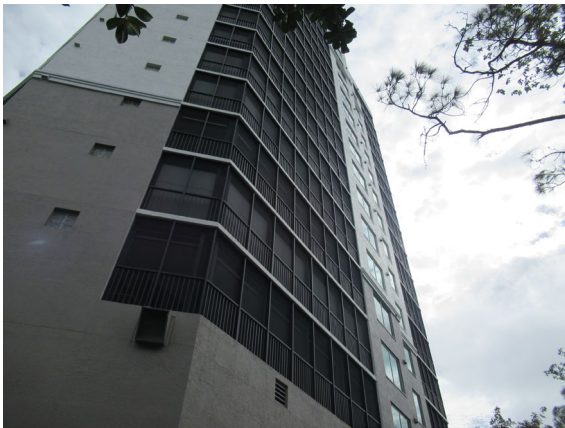
Partial view of southern façade.

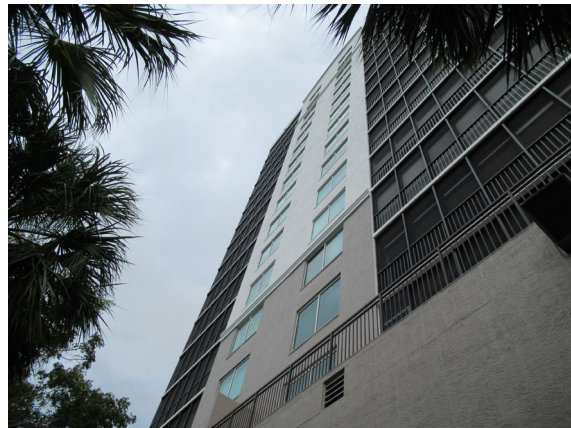
Partial view of southern façade.

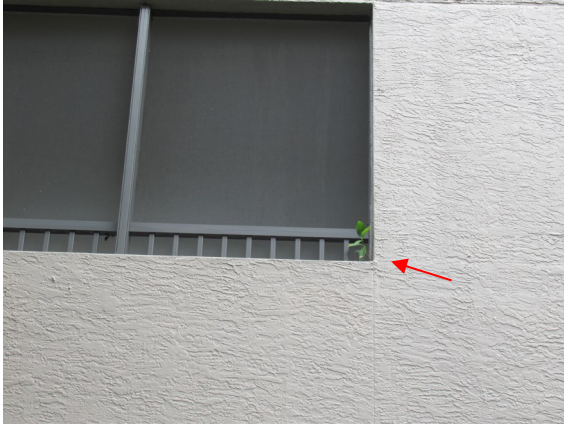
View of vegetative growth on the southern facade.

- In general, there are typical concrete shrinkage cracks on several sections of the parking lot concrete topping that is poured over the structural slab.
- Vegetative growth as indicated on Appendix A.

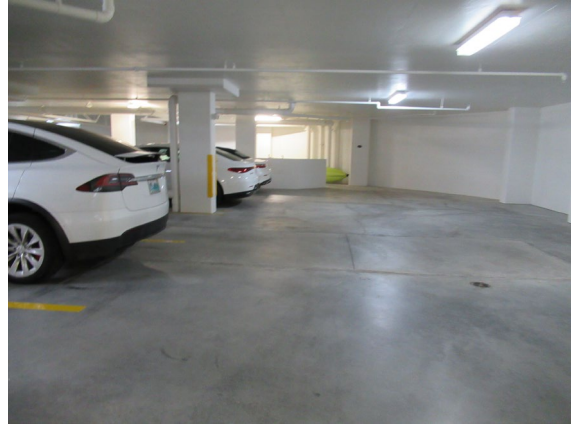
General view of the covered parking area.

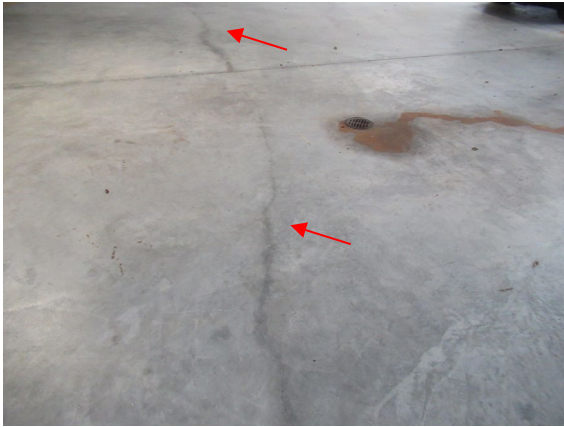
View of typical concrete topping shrinkage cracks.

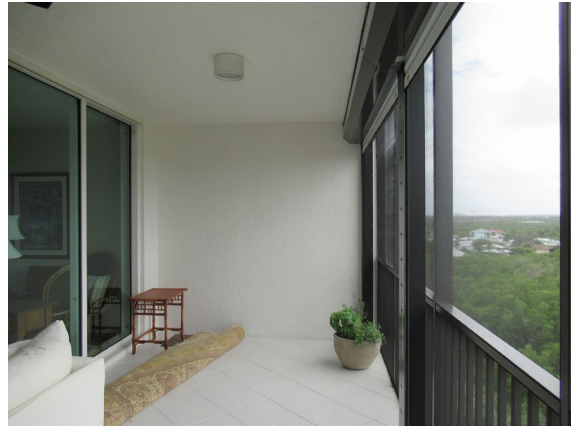
View of balcony with ceramic tile unit 1001.

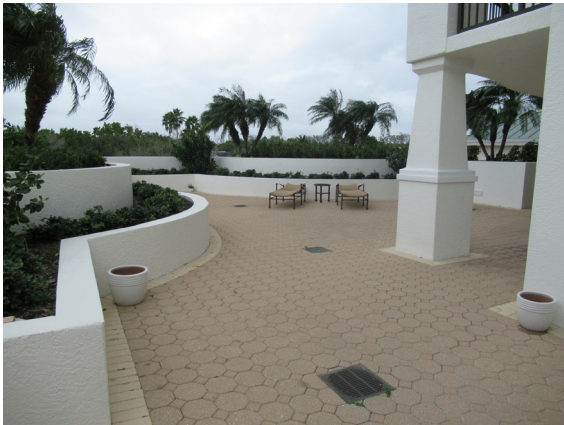
View of exterior terrace unit 403.

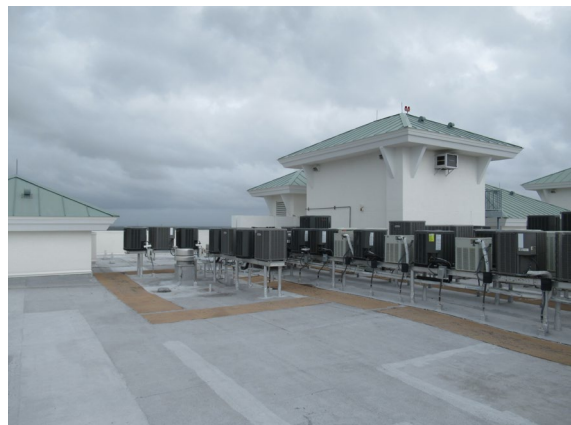
View of roof section and HVAC equipment.
