**MILESTONE INSPECTION –
PHASE I REPORT**

Nevis Condominium
455 Cove Tower Drive
Naples, Florida 34110

SOCOTEC Project Number VS233602

January 2024

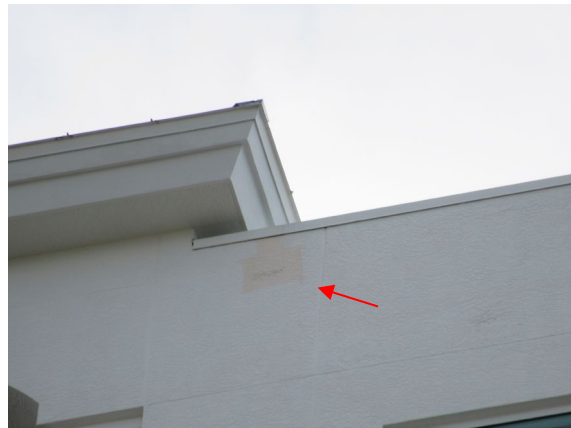
View of missed coating section on the western facade.

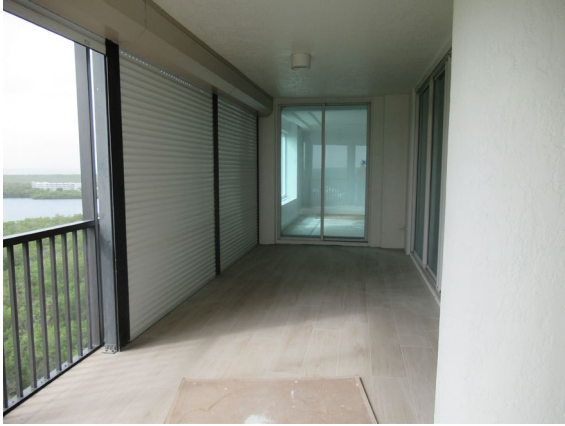
View of balcony with ceramic tile and shutters unit 1404.

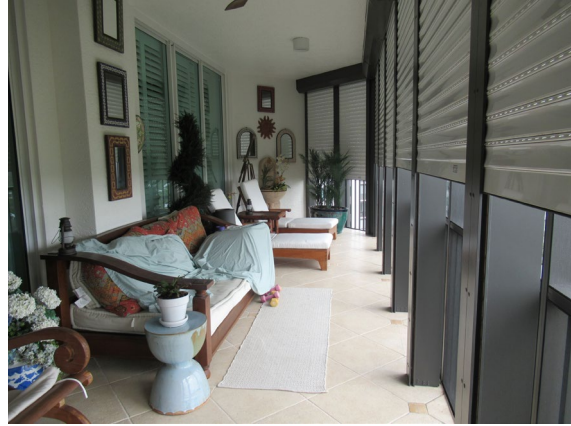
View of balcony with ceramic tile and shutters unit 1603.

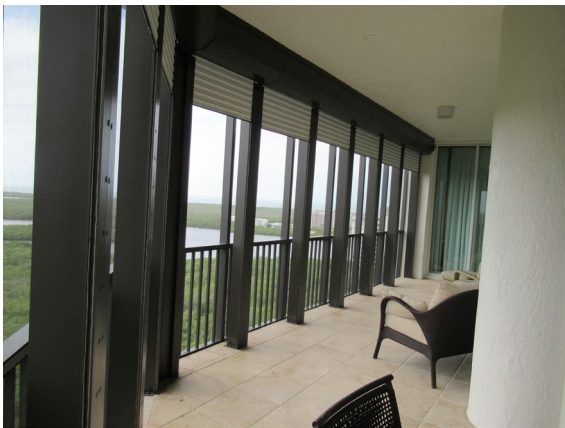
View of balcony with ceramic tile and shutters unit 1802.

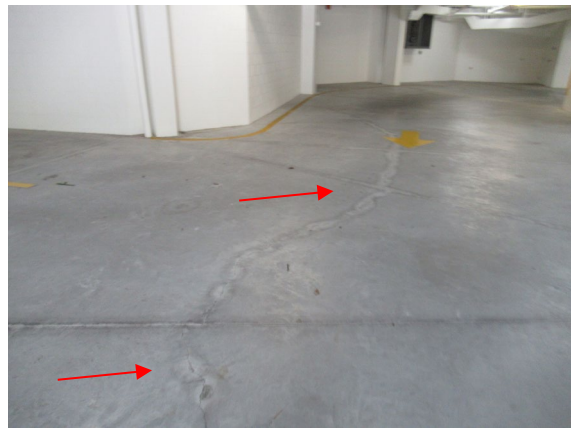
View of typical concrete topping shrinkage cracks.

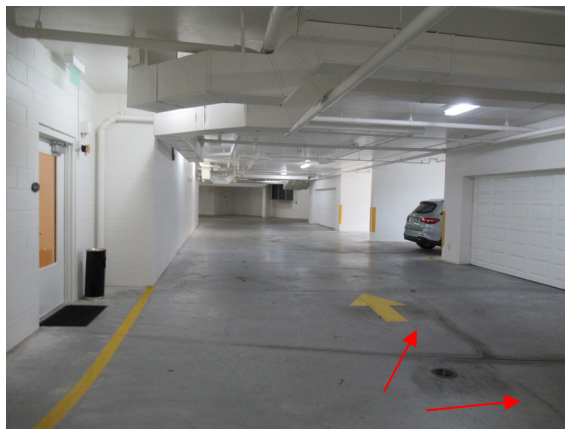
View of typical concrete topping shrinkage cracks.
