STRUCTURAL INTEGRITY RESERVE STUDY

Montego Condominium
445 Cove Tower Drive
Naples, Florida 34110

SOCOTEC Project Number VS233602

March 2024

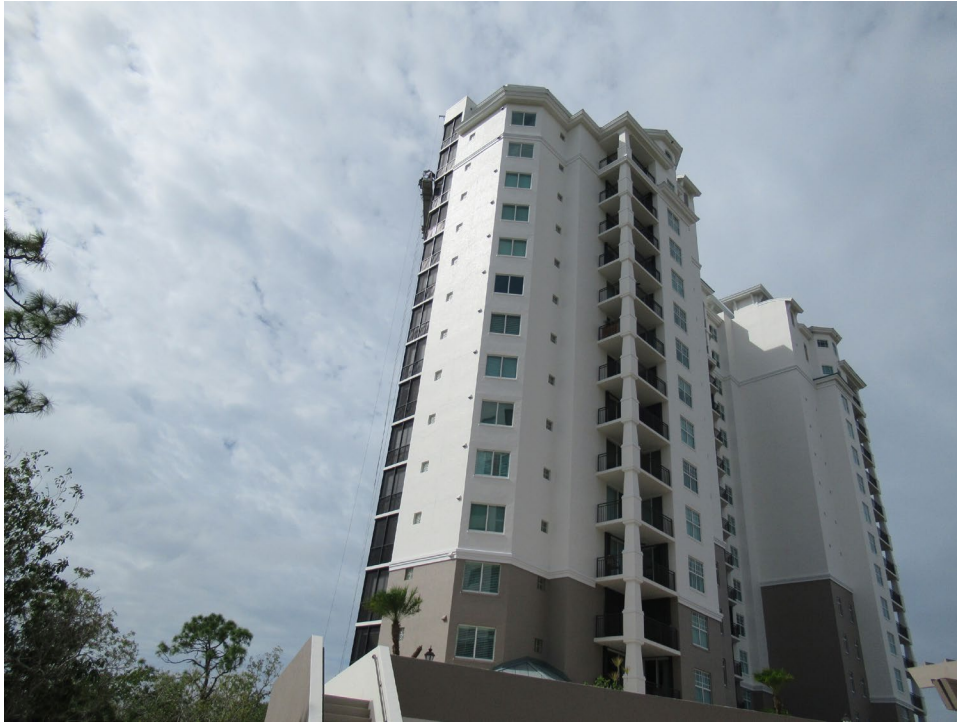
Photo 1 - Partial view of building east elevation.

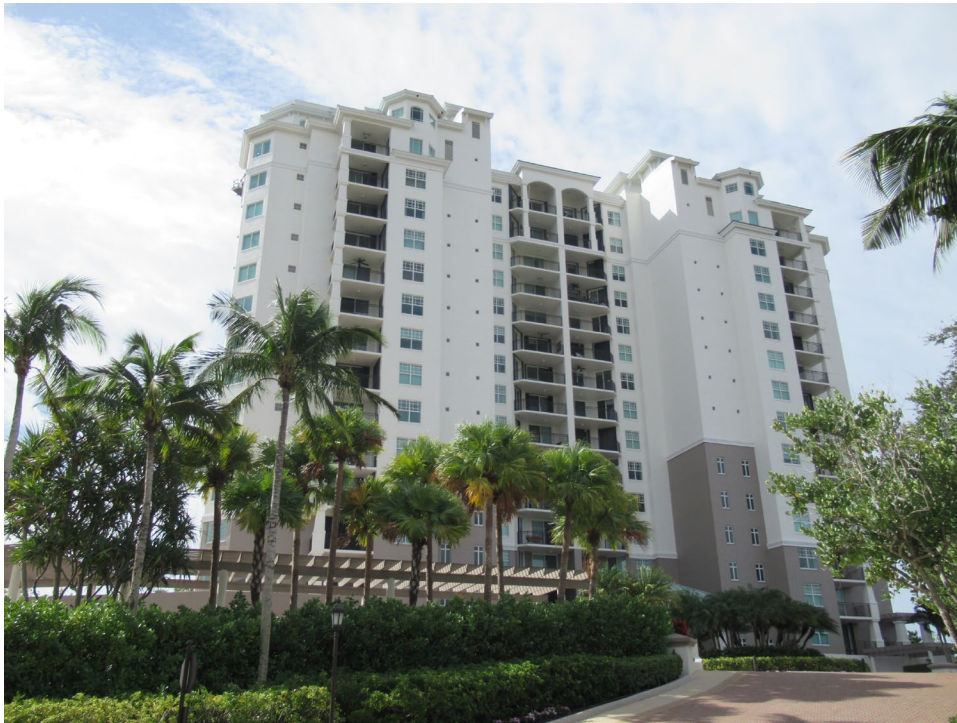
Photo 2 - Partial view of building north elevation.

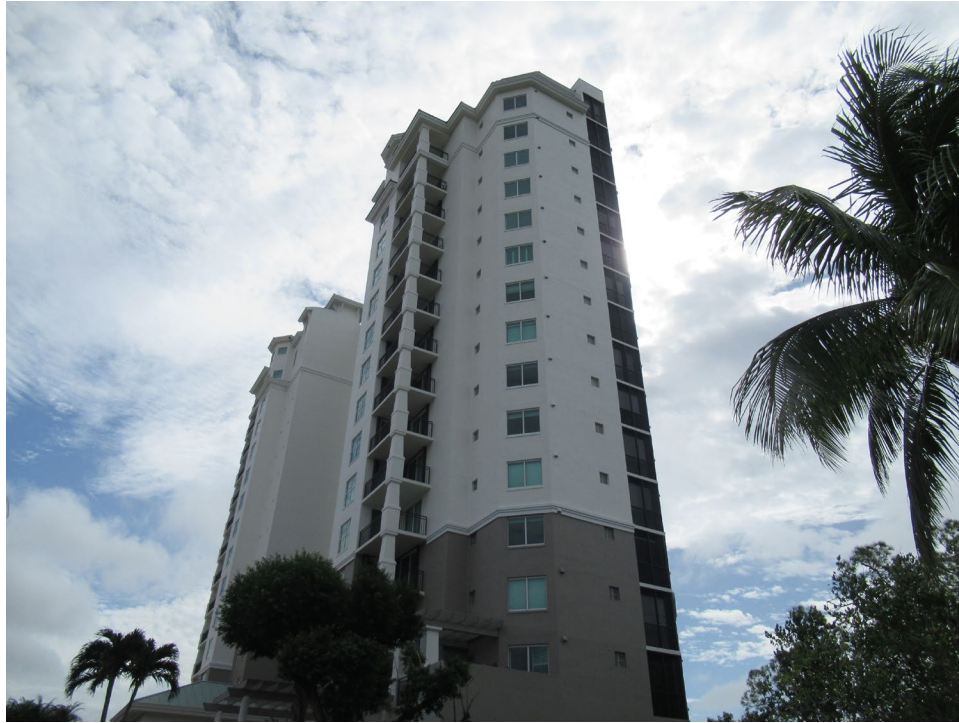
Photo 3 – Partial view of building west elevation.

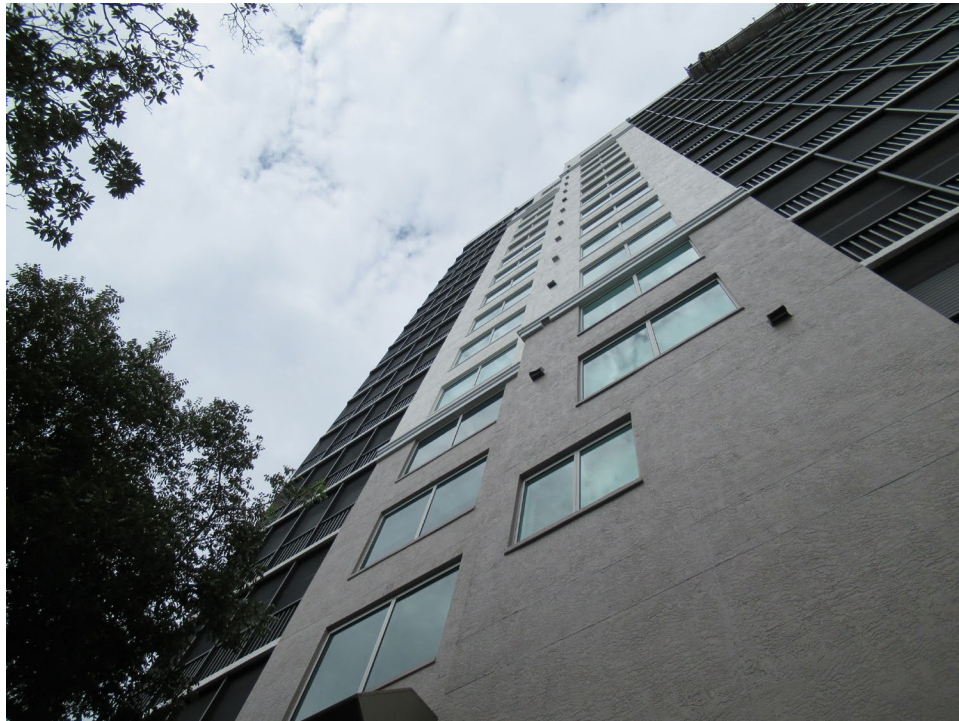
Photo 4 – Partial view of building south elevation.

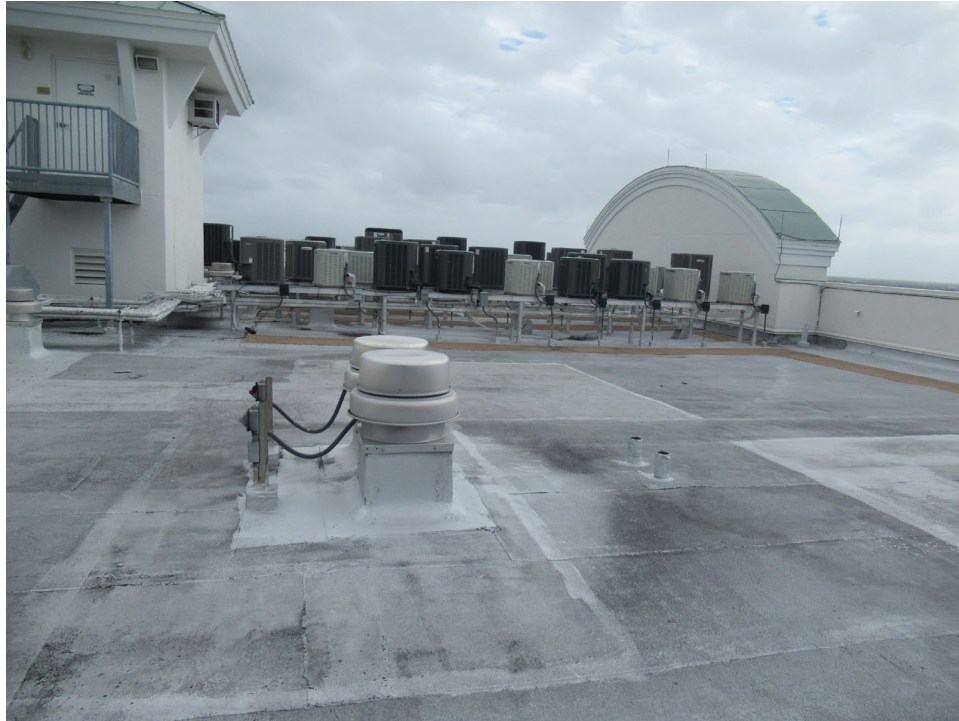
At the time of our site visit, the roof systems were observed to be in good overall condition. We have included a reserve item for replacement of the roof system based on their useful life cycle.

Photo 5 – View of roof section and HVAC equipment.

Main Roof – TPO – The flat roof system on the condominium building consists of a TPO membrane. Most TPO roof covering systems typically achieve a useful life of approximately 20 to 30 years depending on the thickness, quality of initial installation, and with normal upkeep and maintenance. We understand that the TPO membrane installation is of original construction (circa 2002) and is at the end of its useful life. Therefore, we recommend that the TPO membrane be scheduled for replacement in the near future.

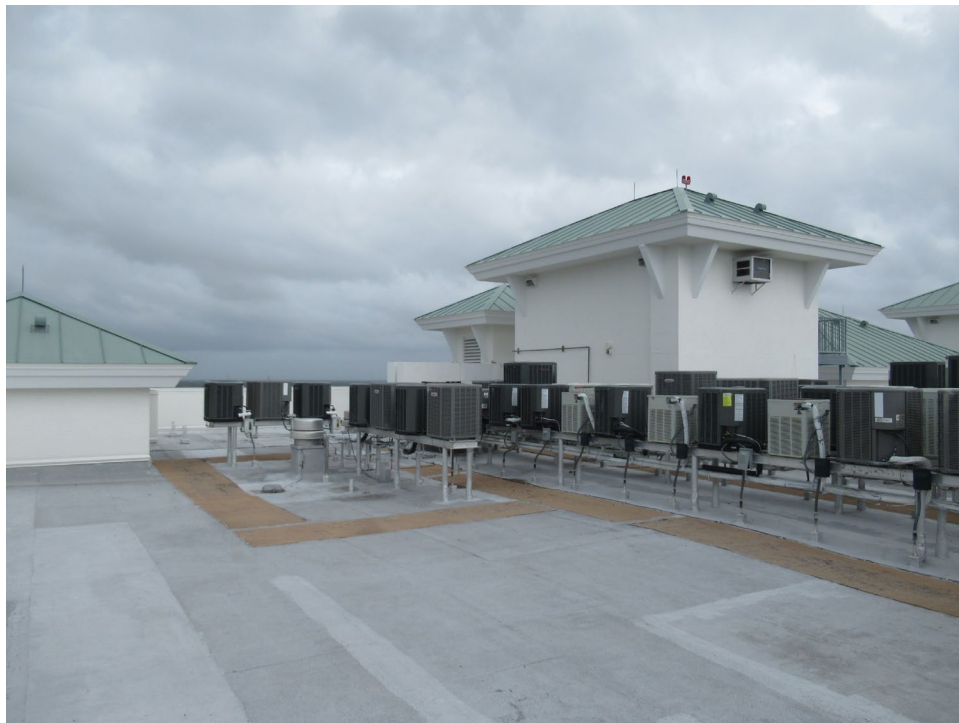
Photo 6 – View of roof section and HVAC equipment.

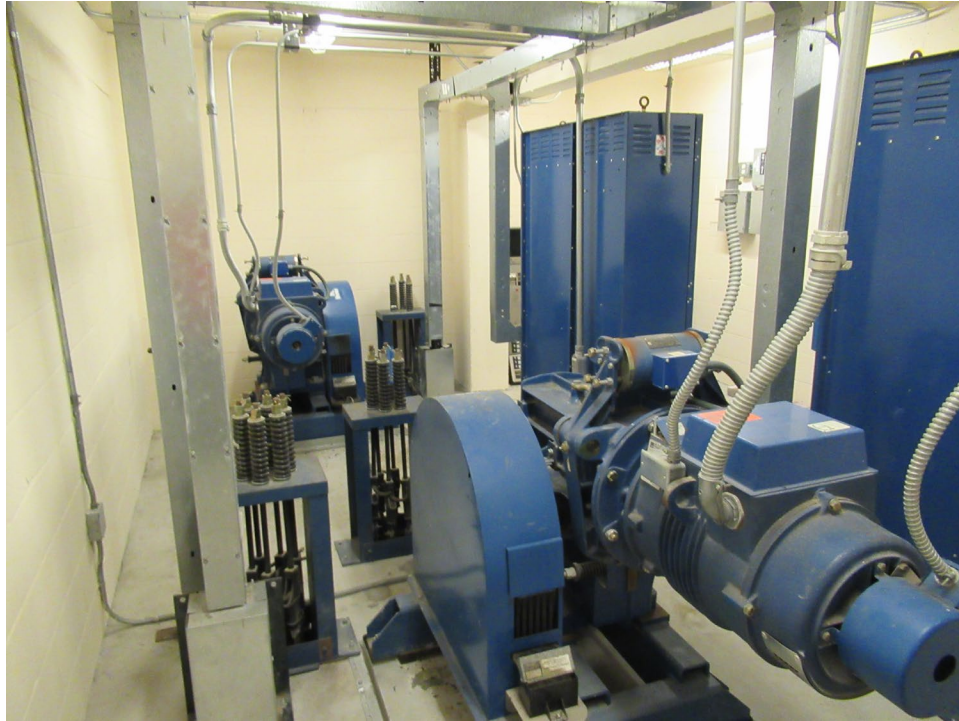
Photo 7 – View of elevator mechanical room.

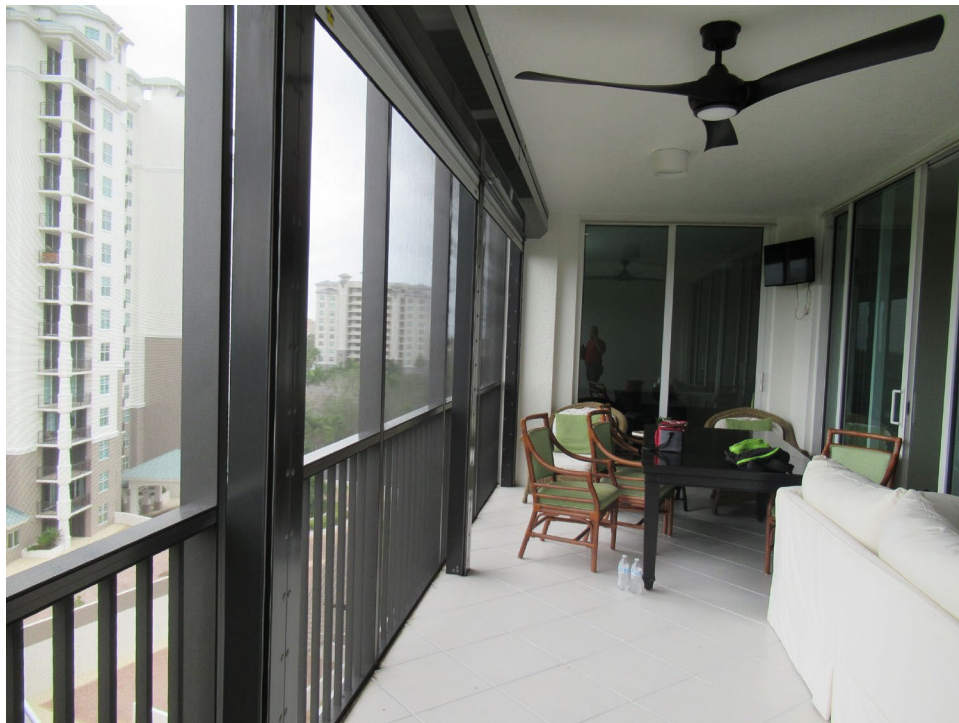
The subject structure includes lanais/balconies with railings. The railings posts are embedded into the structure through cored openings penetrating through the waterproofing and into the structural concrete decks. As these types of railing enclosures age, they offer one of the greatest potentials for moisture entry into the structural slabs. Therefore, we believe these components must be properly maintained to prevent potential damage to the structure. Also, maintenance of these items is a significant life safety item because of their fall-protection aspect. Steel railings have a typical useful life of 60-years with routine maintenance. A reserve for replacement of the railings has been included.

Photo 8 – Typical exterior balcony with ceramic tile.

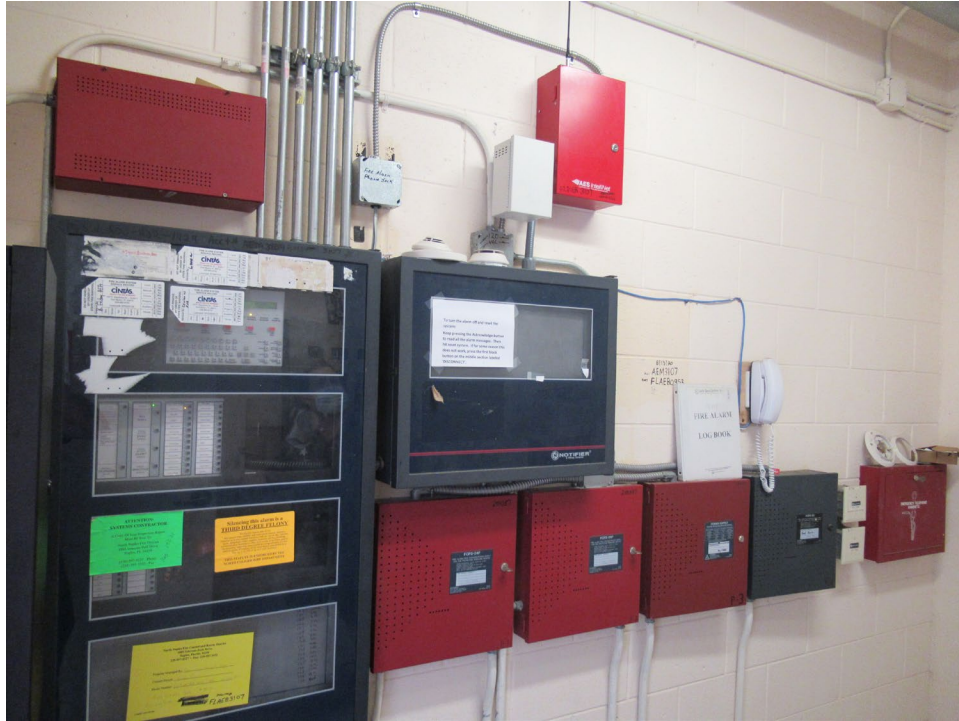
The main fire alarm control panel (FACP) for the condominium is from original construction and it is shared by Nevis and Montego Condominiums, it is located in an accessory building electrical room. Numerous audio and visual alarms, fire extinguishers, and fire alarm pull switches are located throughout the subject site. Typically, these control systems have a useful life of 25 to 30 years before requiring an updated system. A reserve has been included for replacement of the FACP and related equipment.

Photo 9 – Fire alarm control panel.

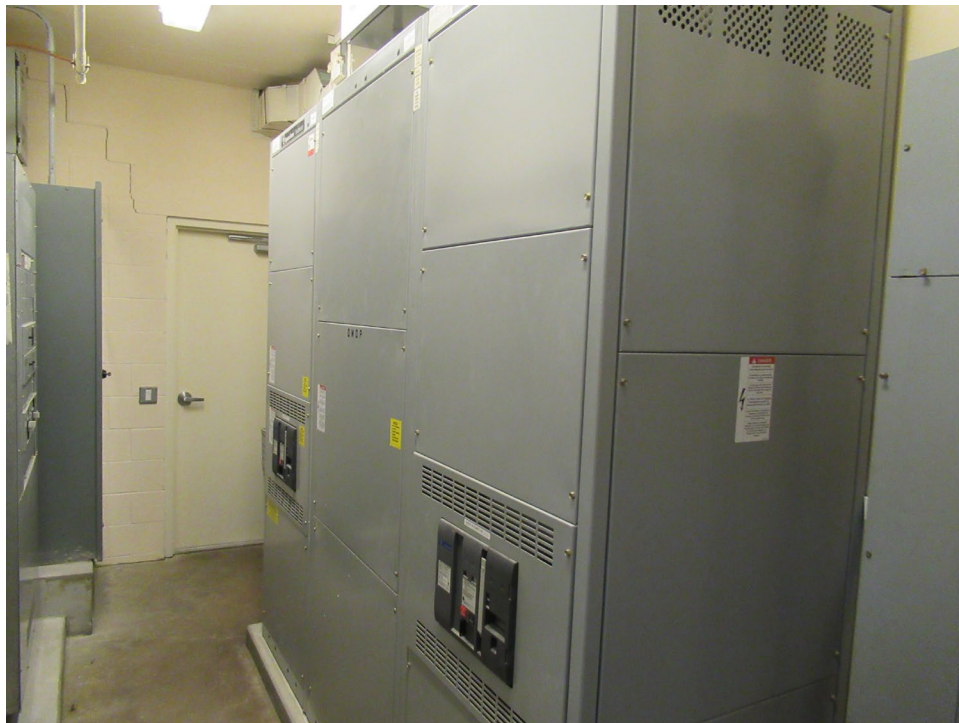
Currently there are no indications of any deterioration or issues with the electrical system for the buildings. This includes the electrical meter centers located with the FACP room on the second floor of the building. Most of the electrical equipment appeared to be in good to fair condition. Localized breaker panels and branch circuits are typically replaced during common area or individual unit renovations as required to accommodate the renovation. A reserve has been included for periodic replacement/upgrades of major electrical system components such as main service panels and feeder lines.

Photo 10 – View of electrical room equipment.

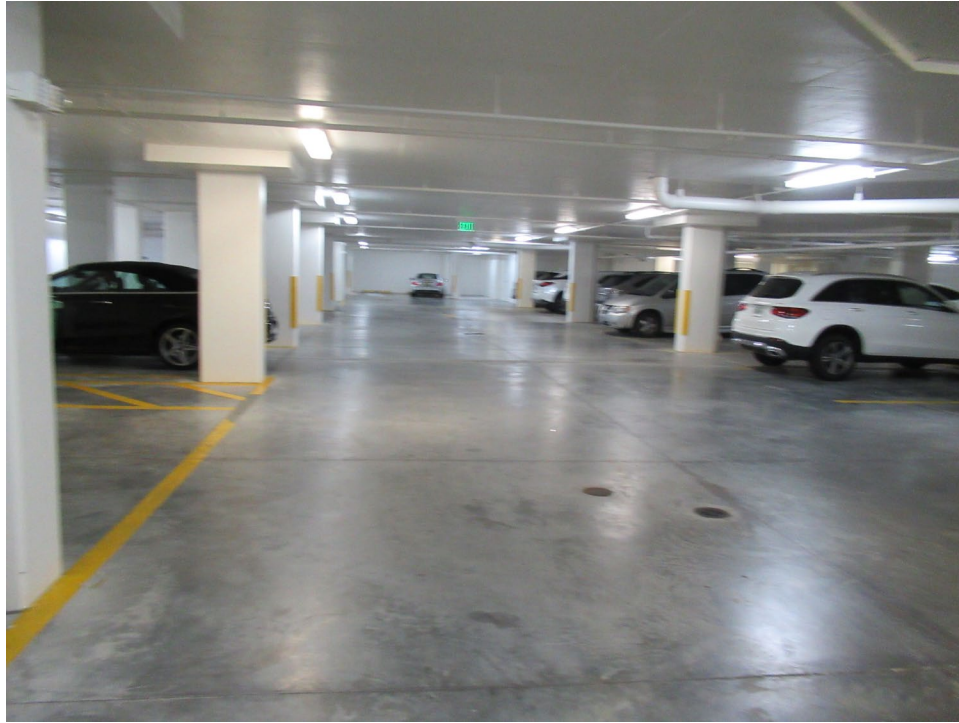
Photo 11 – Partial view of the covered parking area.

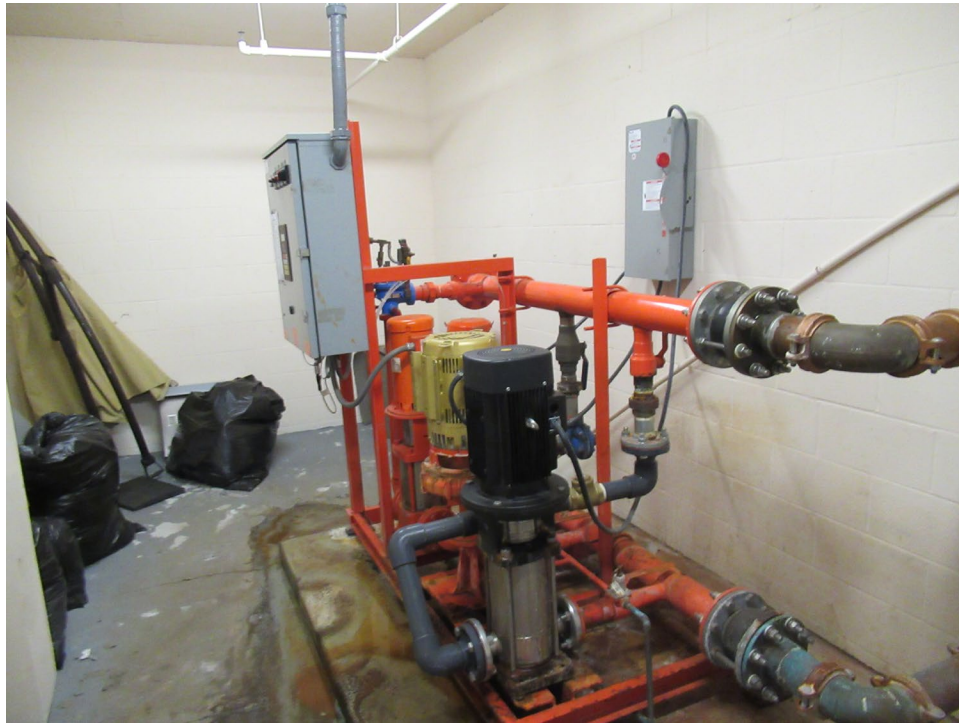
Photo 12 – View of fire pump.
