**STRUCTURAL INTEGRITY RESERVE STUDY**

Nevis Condominium  
455 Cove Tower Drive  
Naples, Florida 34110

SOCOTEC Project Number VS233602

March 2024

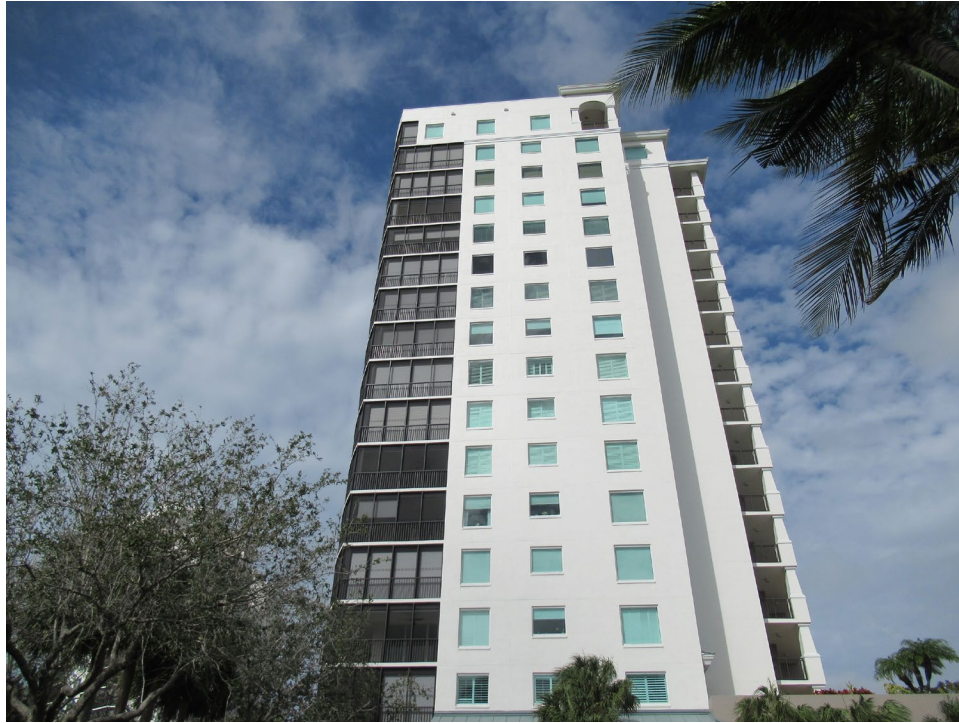
Photo 1 - Partial view of building east elevation.

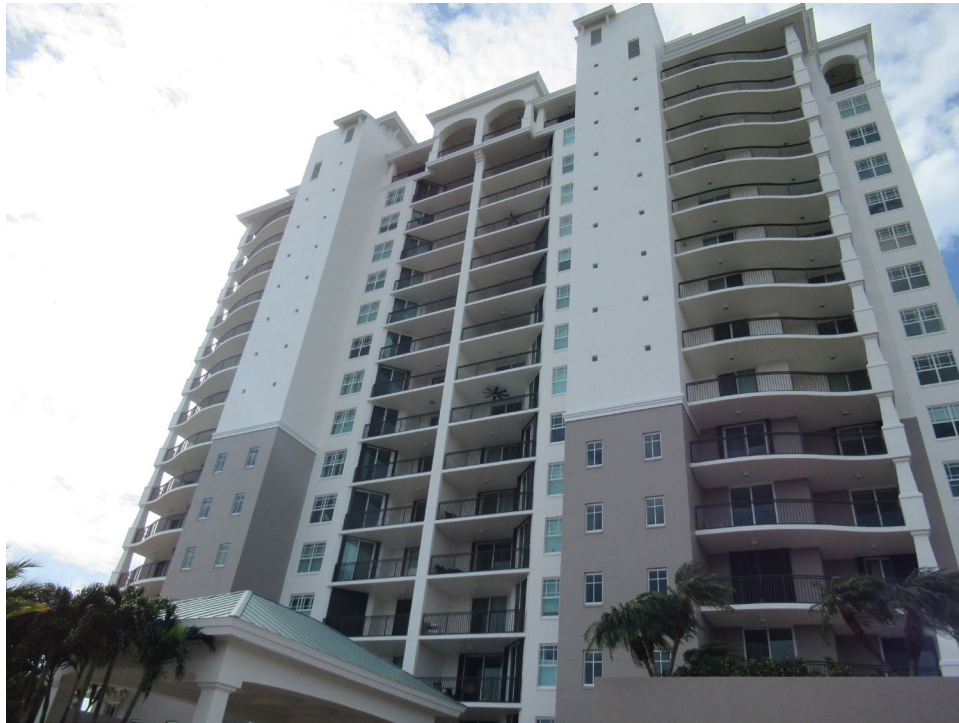
Photo 2 - Partial view of building north elevation.

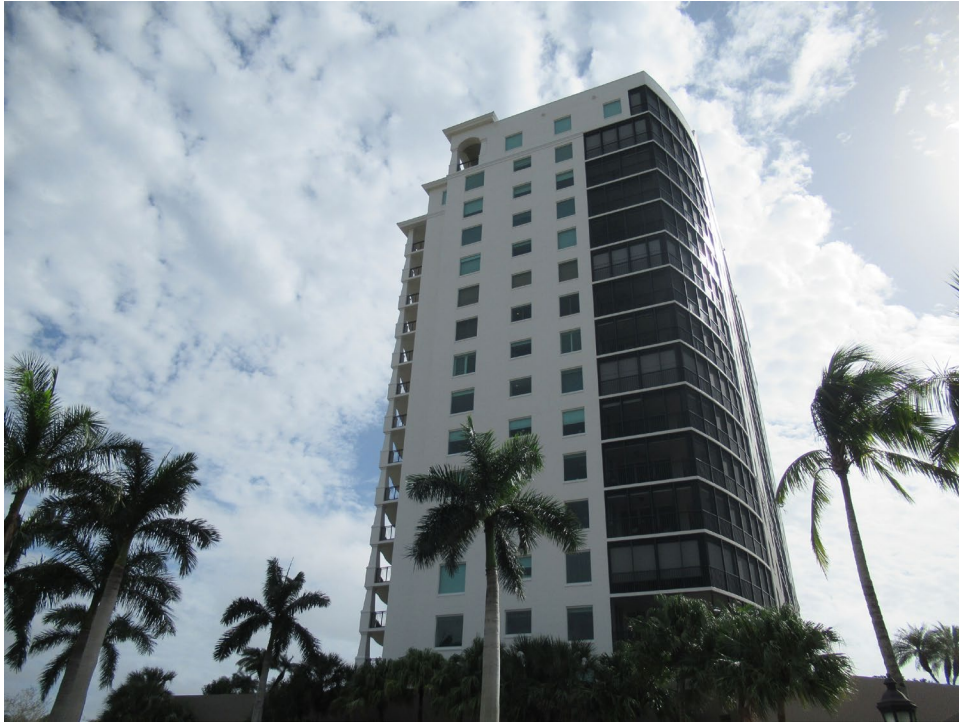
Photo 3 – Partial view of building west elevation.

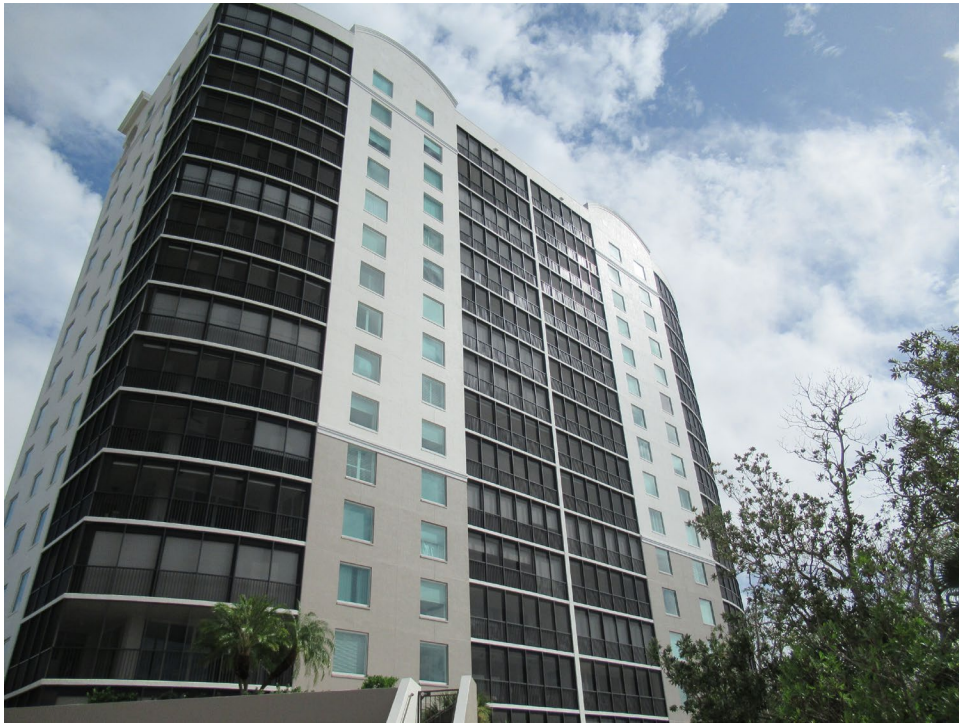
Photo 4 – Partial view of building south elevation.

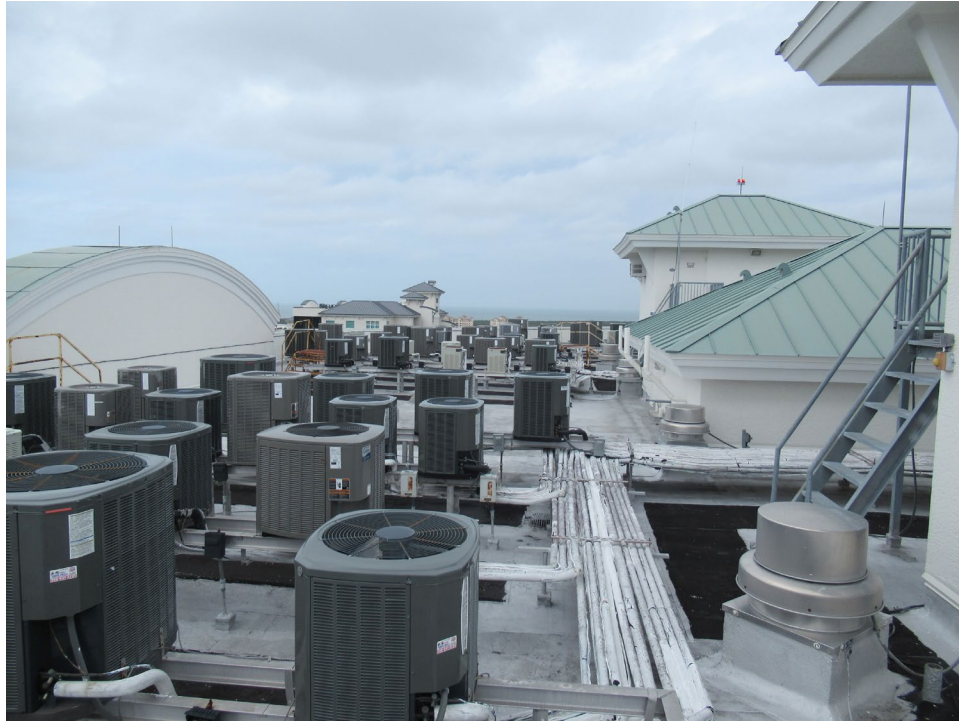
At the time of our site visit, the roof systems were observed to be in good overall condition. We have included a reserve item for replacement of the roof system based on their useful life cycle.

Photo 5 – View of roof section and HVAC equipment.

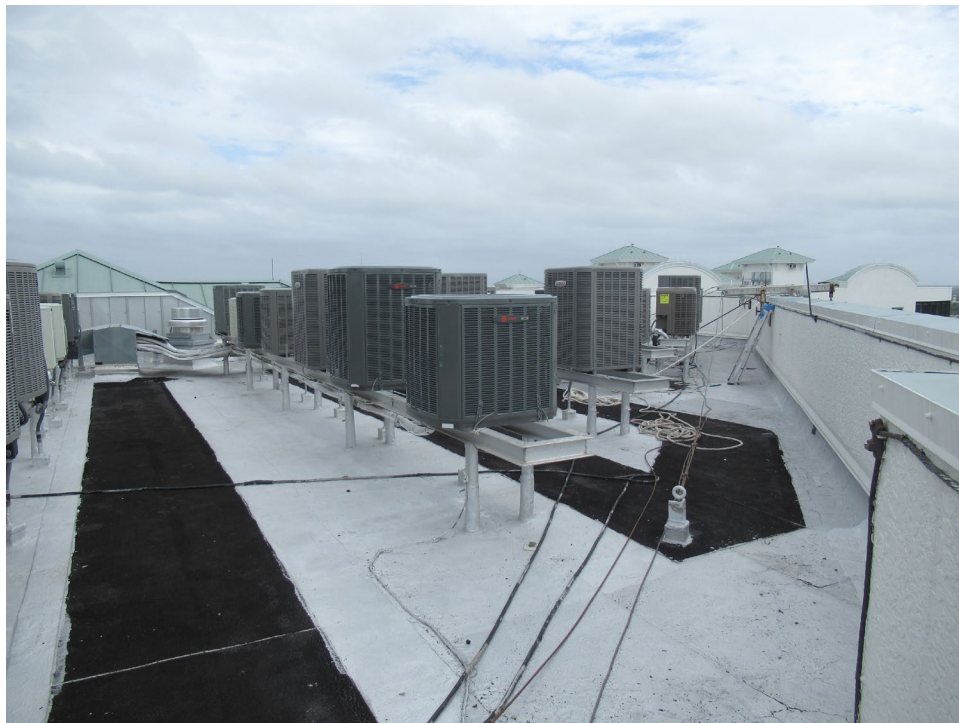
Photo 6 – View of roof section and HVAC equipment.

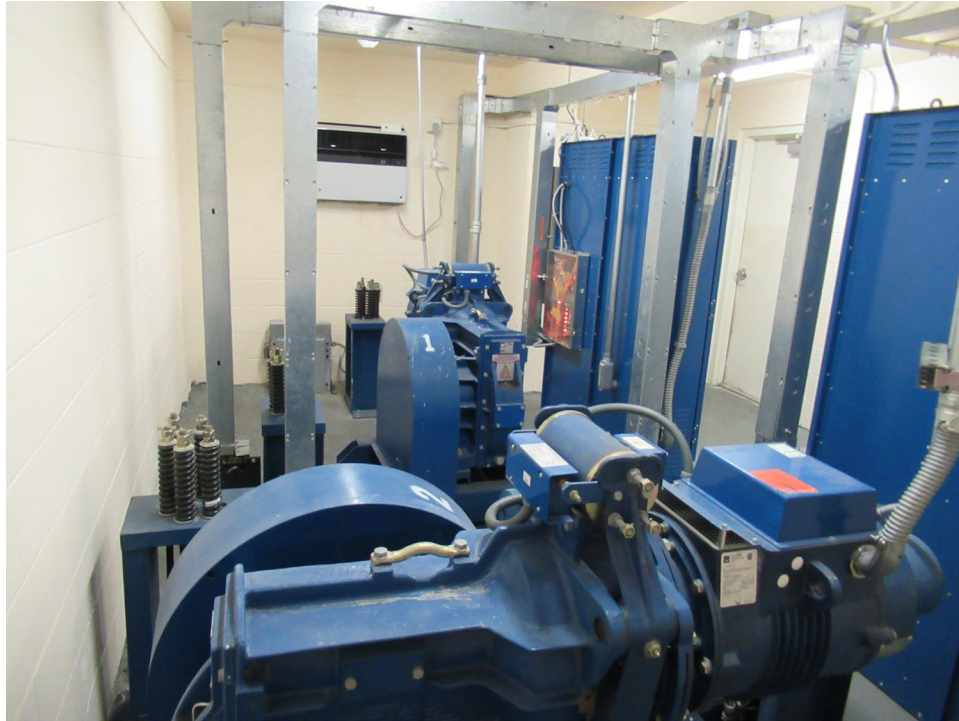
Photo 7 – View of elevator mechanical room.

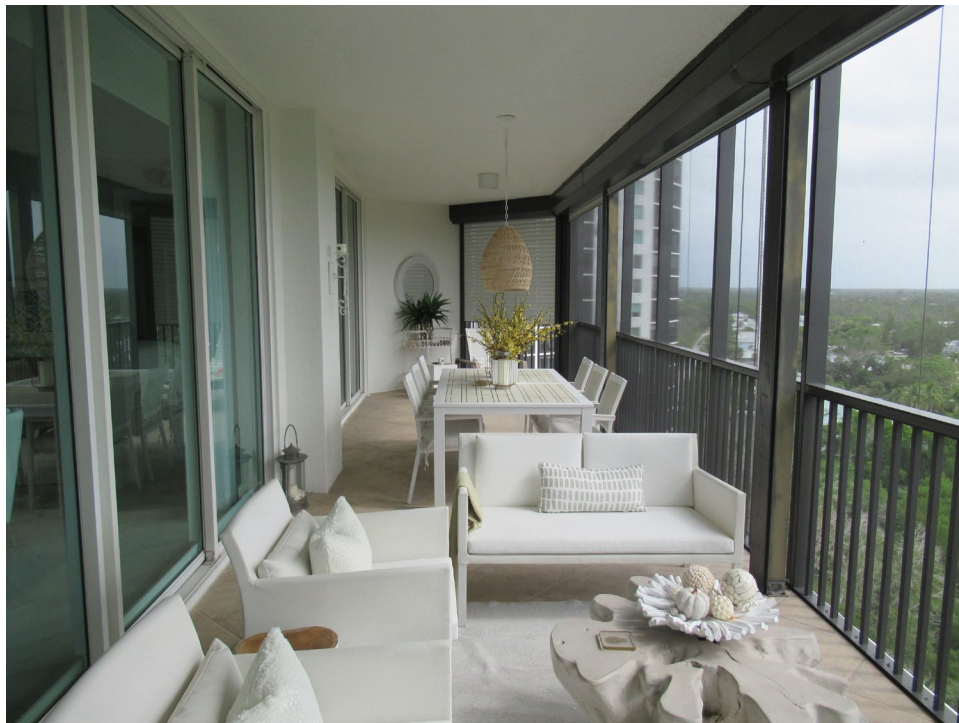
The subject structure includes lanais/balconies with railings. The railings posts are embedded into the structure through cored openings penetrating through the waterproofing and into the structural concrete decks. As these types of railing enclosures age, they offer one of the greatest potentials for moisture entry into the structural slabs. Therefore, we believe these components must be properly maintained to prevent potential damage to the structure. Also, maintenance of these items is a significant life safety item because of their fall-protection aspect. Steel railings have a typical useful life of 60-years with routine maintenance. A reserve for replacement of the railings has been included.

Photo 8 – Typical exterior balcony with ceramic tile.

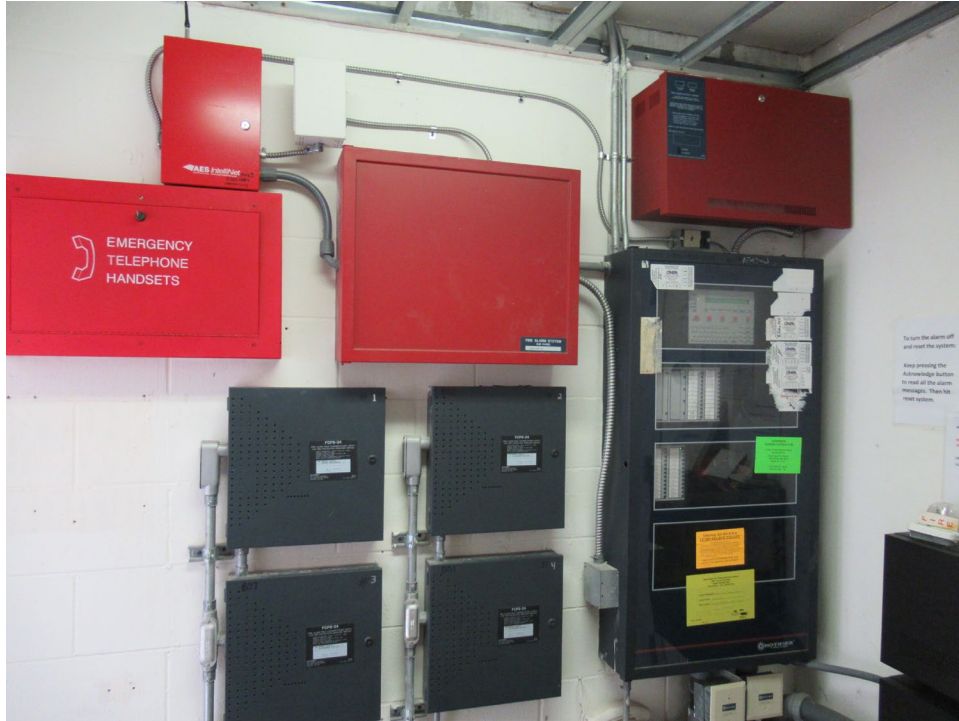
The main fire alarm control panel (FACP) for the condominium is from original construction and it is shared by Nevis and Montego Condominiums, it is located in an accessory building electrical room. Numerous audio and visual alarms, fire extinguishers, and fire alarm pull switches are located throughout the subject site. Typically, these control systems have a useful life of 25 to 30 years before requiring an updated system. A reserve has been included for replacement of the FACP and related equipment.

Photo 9 – Fire alarm control panel.

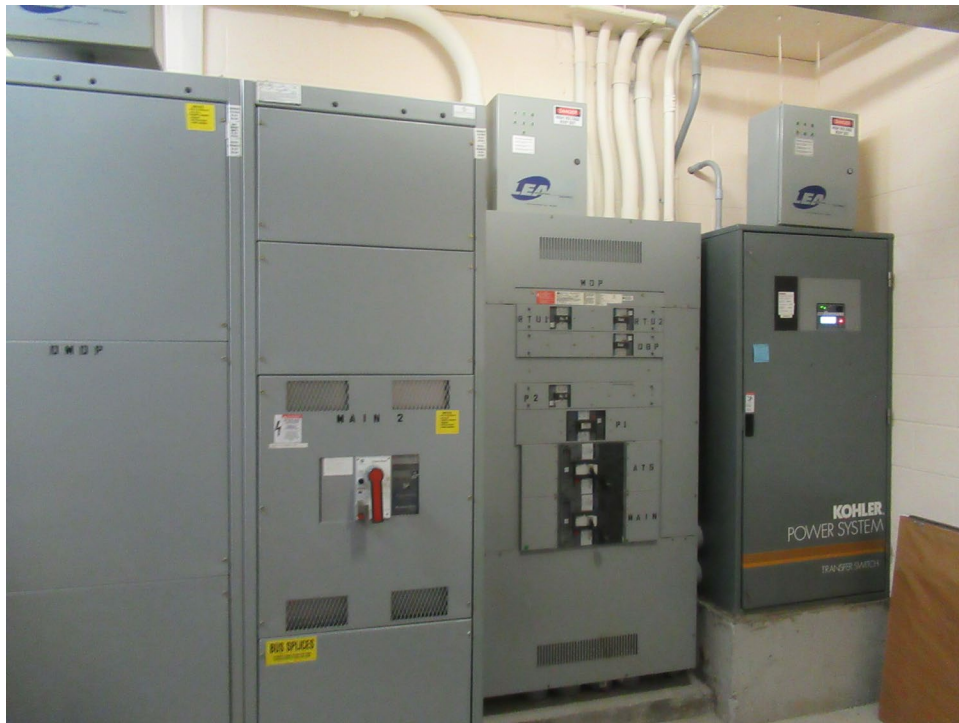
Currently there are no indications of any deterioration or issues with the electrical system for the buildings. This includes the electrical meter centers located with the FACP room on the second floor of the building. Most of the electrical equipment appeared to be in good to fair condition. Localized breaker panels and branch circuits are typically replaced during common area or individual unit renovations as required to accommodate the renovation. A reserve has been included for periodic replacement/upgrades of major electrical system components such as main service panels and feeder lines.

Photo 10 – View of electrical room equipment.

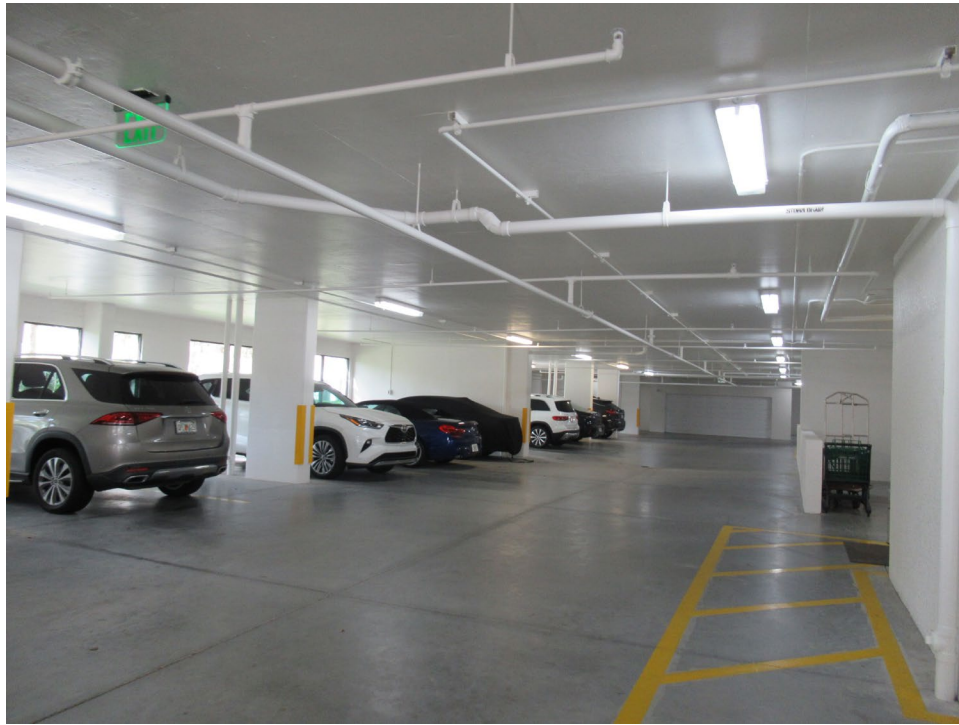
Photo 11 – Partial view of the covered parking area.

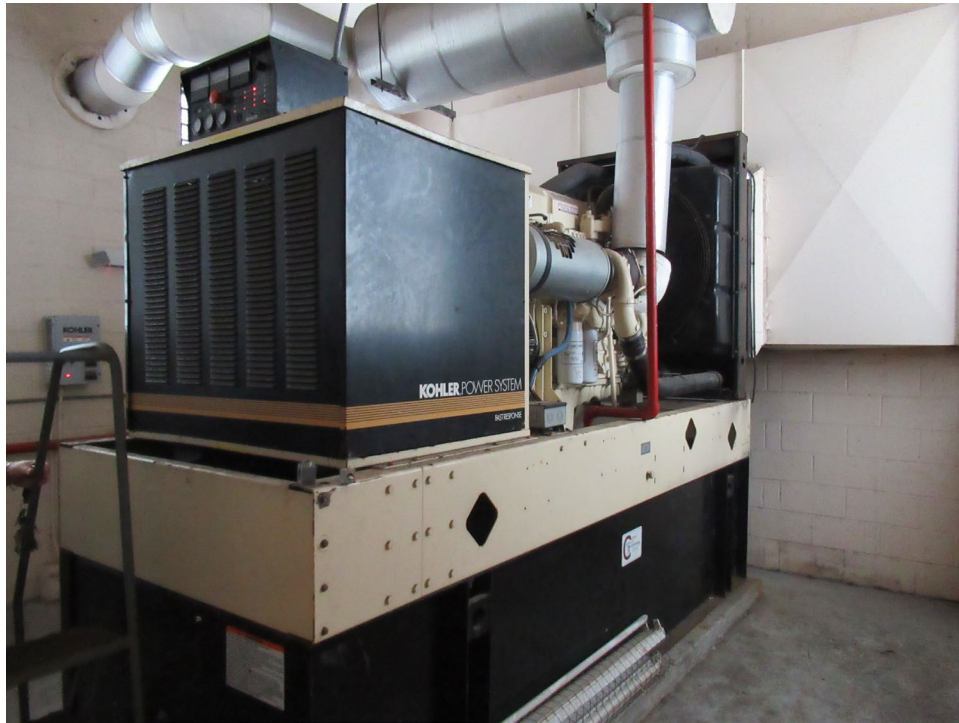
Photo 12 – View of electrical generator.
