**MILESTONE INSPECTION –  
PHASE I REPORT**

Montego Condominium  
445 Cove Tower Drive  
Naples, Florida 34110

SOCOTEC Project Number VS233602

December 2023

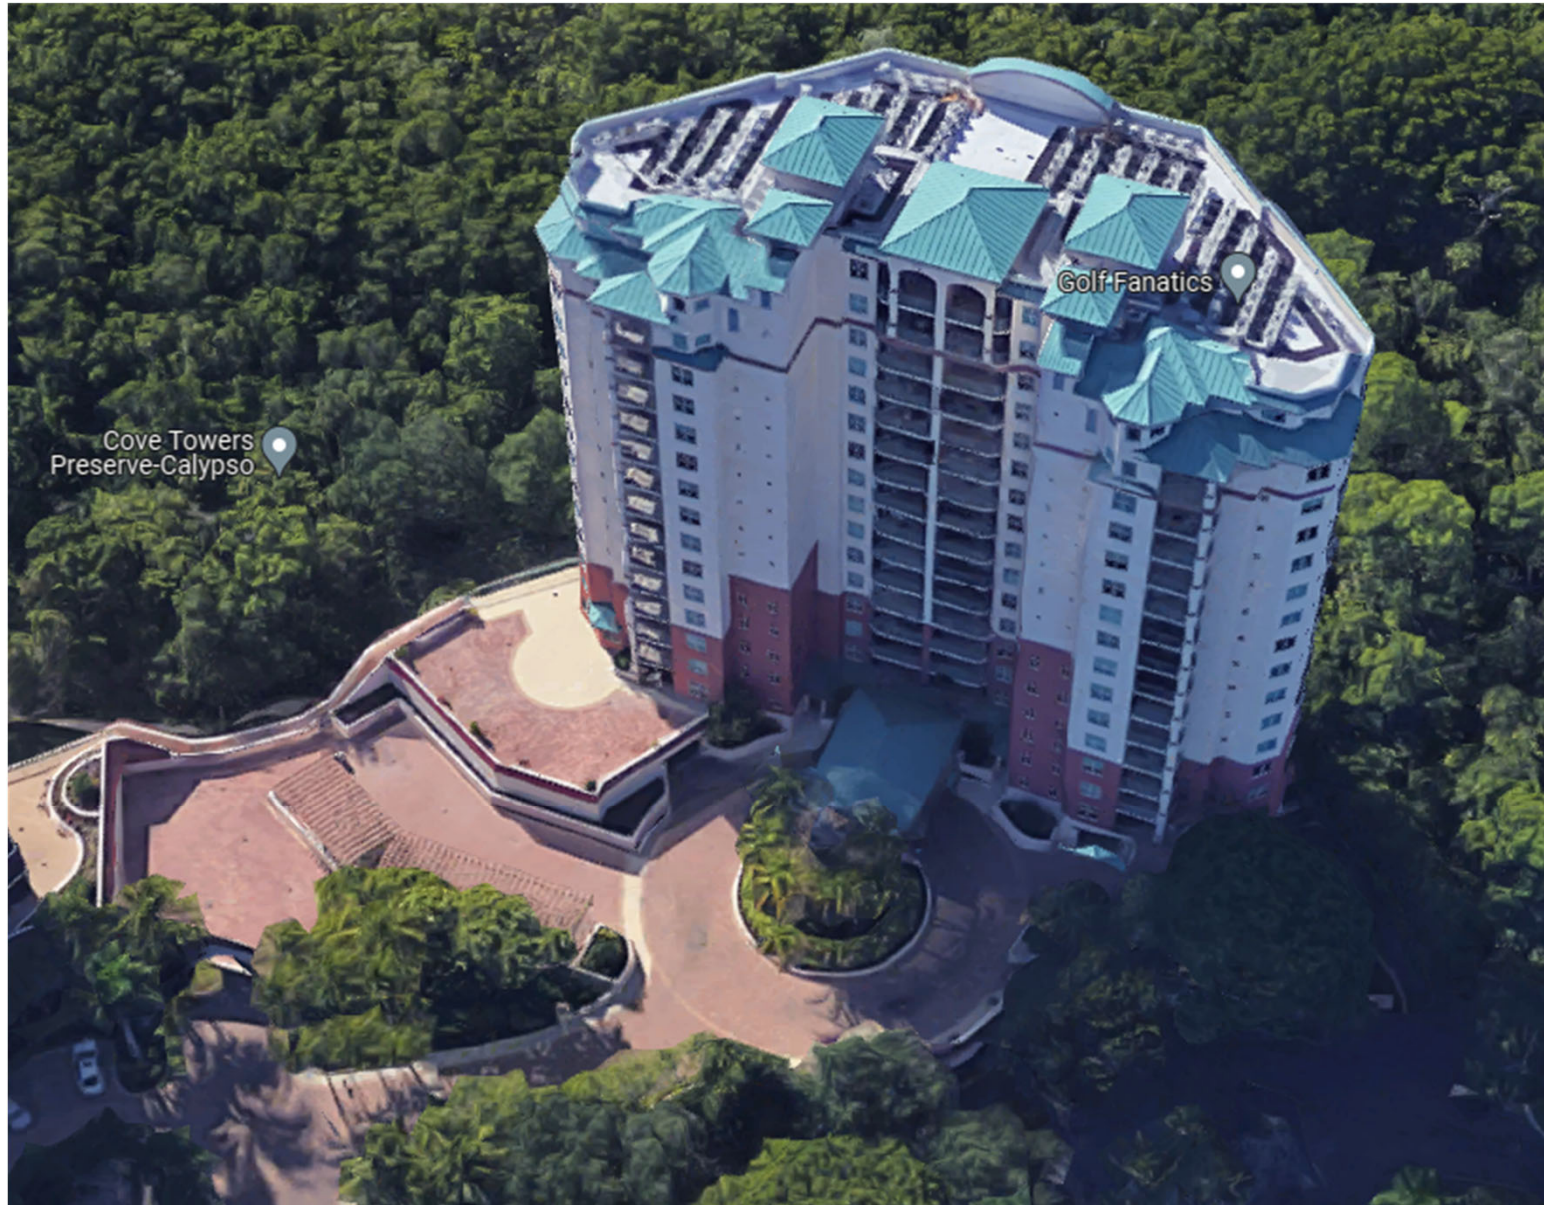
# **APPENDIX A**

- All areas indicated on Appendix A as distressed stucco or concrete.
- Damaged paint coating/efflorescence as indicated on Appendix A.

- In general, there are typical concrete shrinkage cracks on several sections of the parking lot concrete topping that is poured over the structural slab.
- Vegetative growth as indicated on Appendix A.

During our phase I inspection we observed the following building components that should be considered for repair/replacement within the near future. Please note that these items are not considered substantial structural deterioration:
